INSPECTION REPORT

WYNNY STREET

LANGLEY, BC

Inspection Date: Friday, June 18, 2010

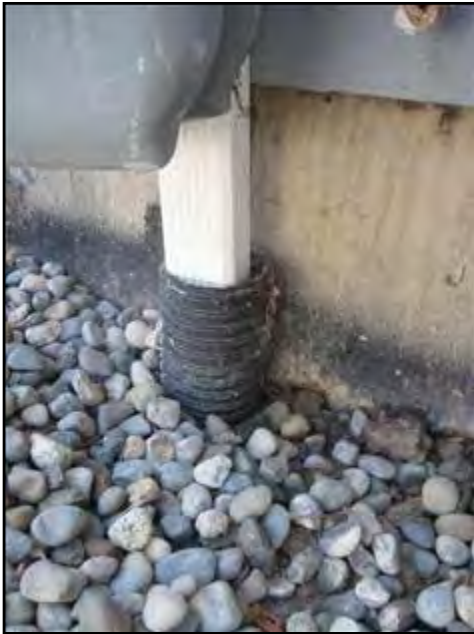
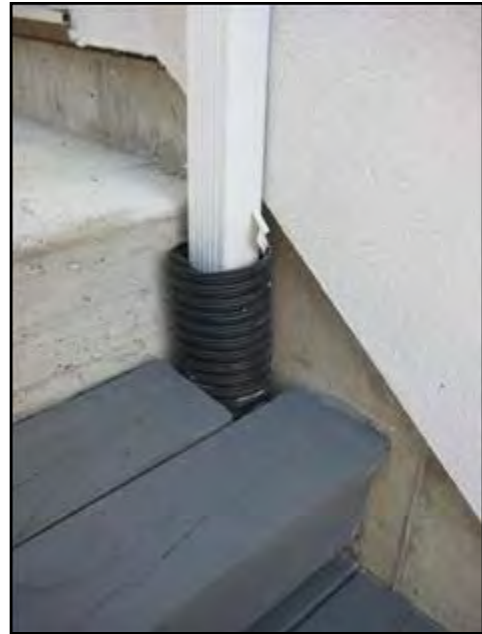
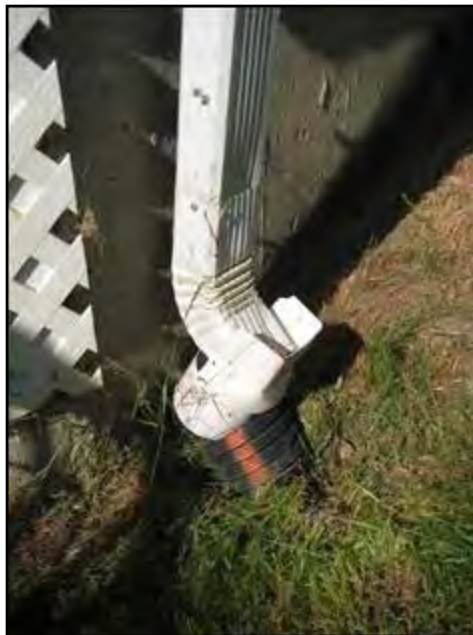
"Big-O" drantile is not typical material used on a house of this age.

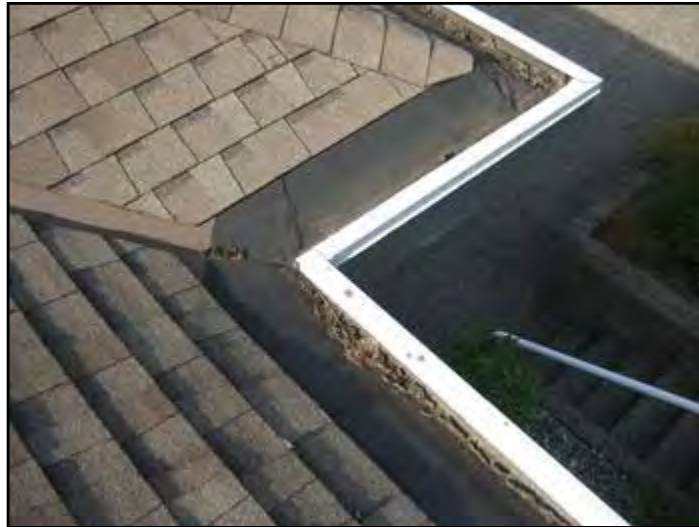
9.

2. Condition: • Non fully adhered rubber membrane on hidden gutter systems is vulnerable to thermal expansion & contraction and subsequent separation at seams & drains. Monitor closely for leaks & repair with compatible product when required.

Task: Monitor & Repair

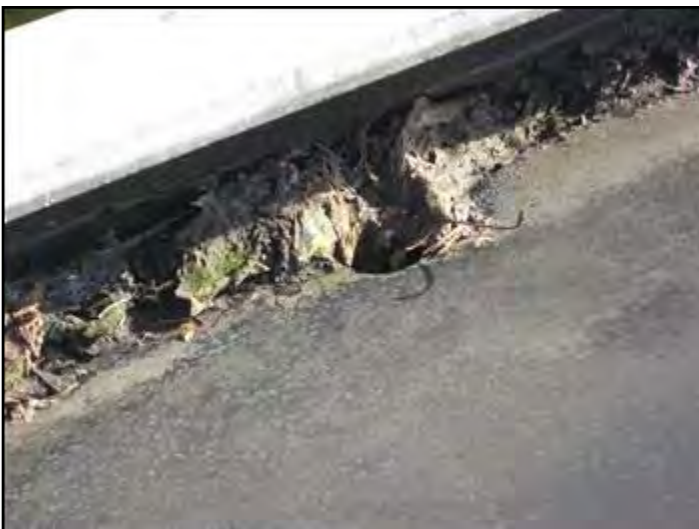
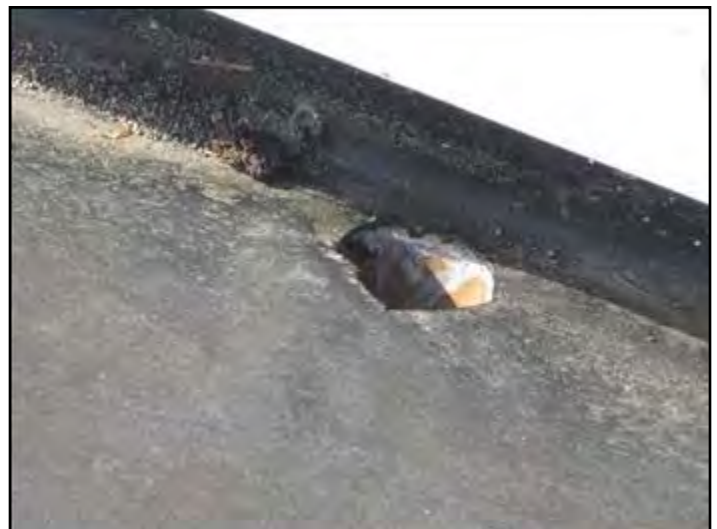
3. Condition: • Downspout screens missing.

Task: Provide

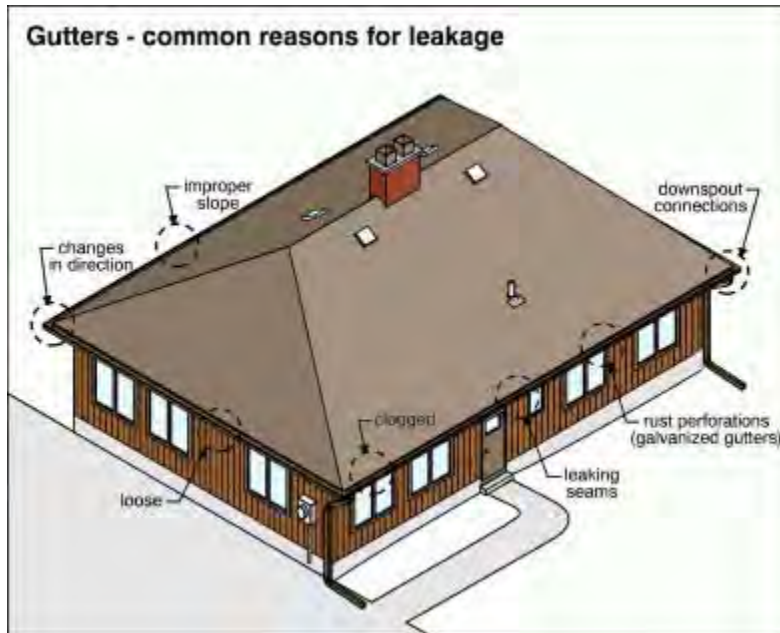
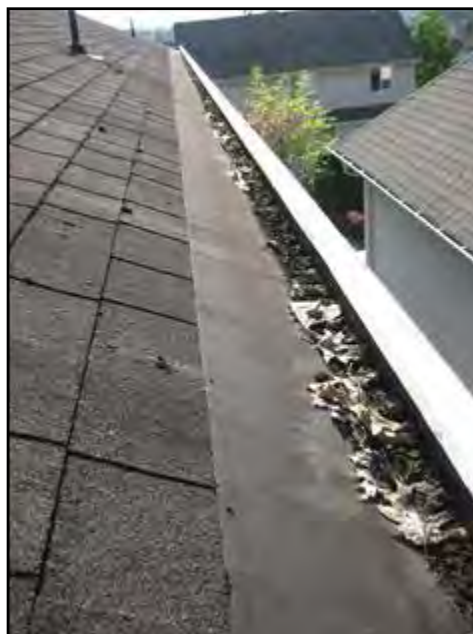
4. Condition: • [Clogged](#)

Implication(s): Chance of water damage to contents, finishes and/or structure

Task: Improve

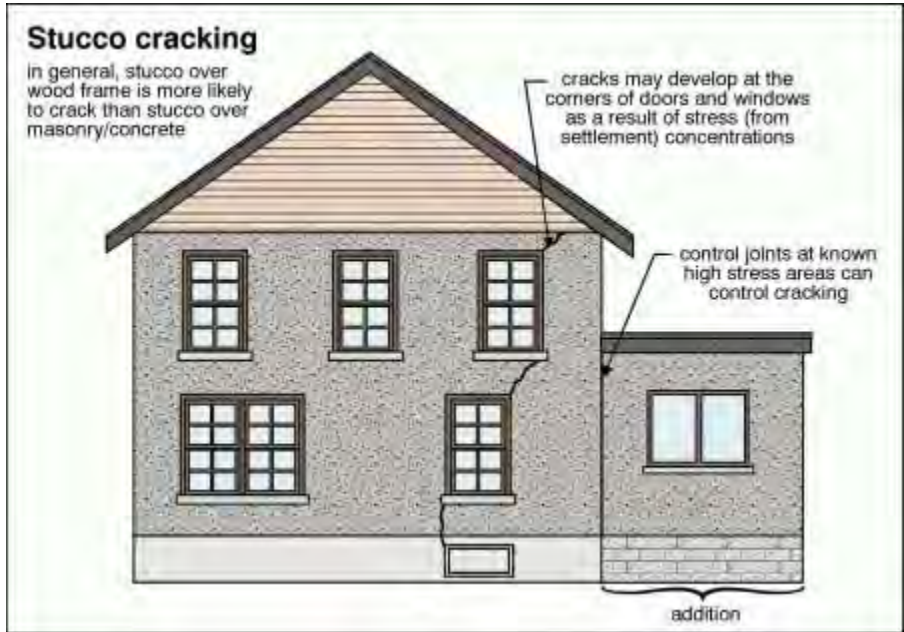
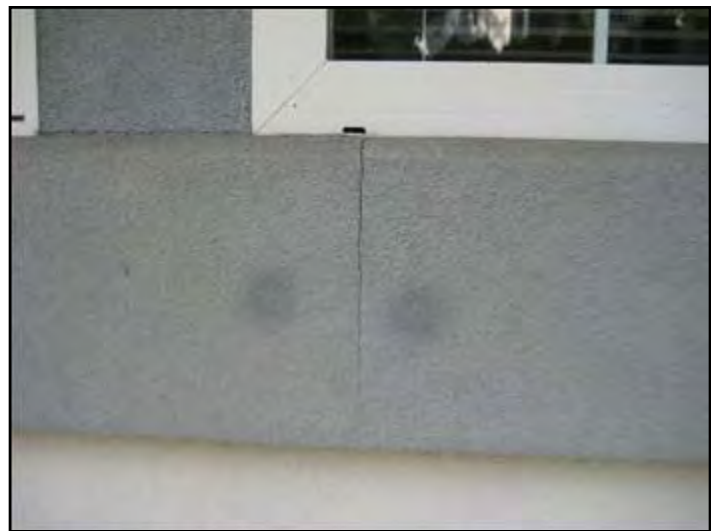
5. Condition: • [Cracked](#)

EIFS trim

Implication(s): Chance of water damage to contents, finishes and/or structure | Material deterioration

Task: Repair

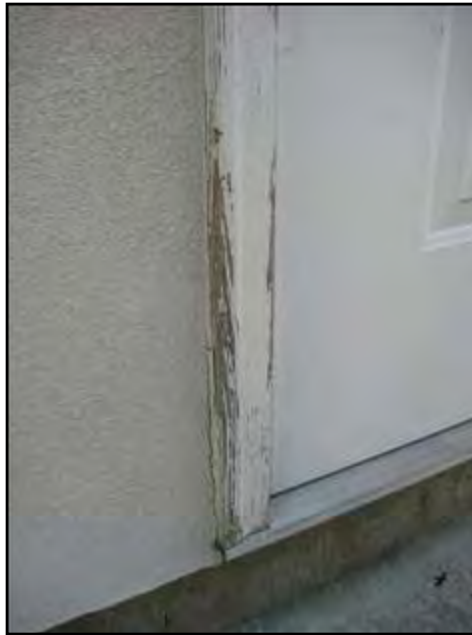
7. Condition: • [Paint or stain needed](#)

15. North garage door

Task: Improve

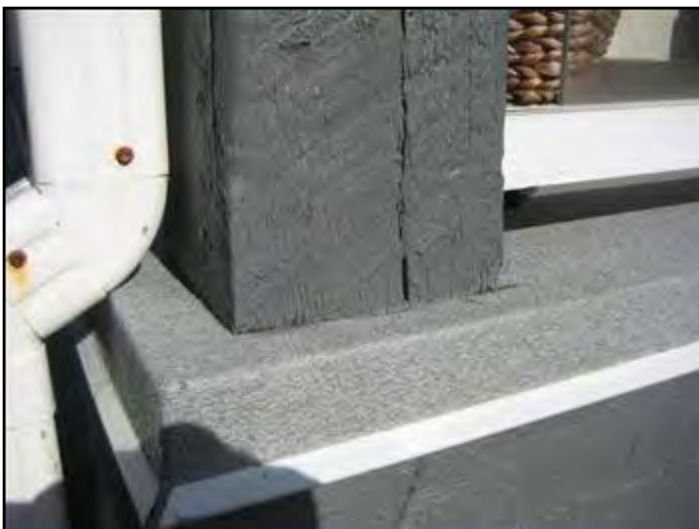
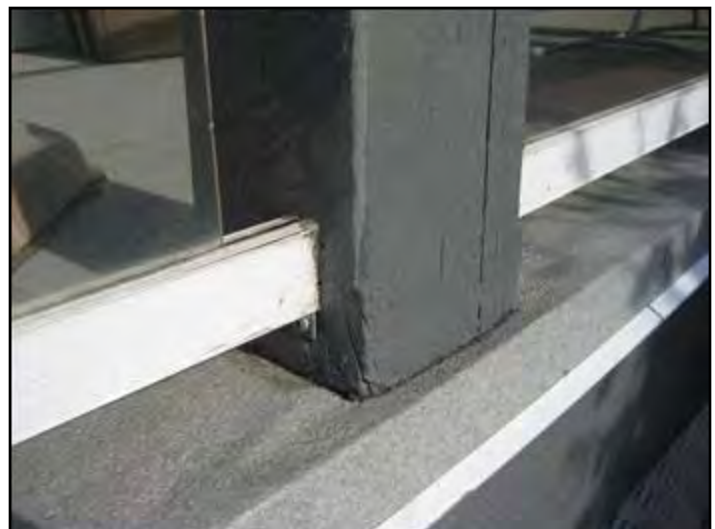
6x6 posts supporting upper deck unconventionally installed overtop vinyl membrane. Visible plywood rot, water stains underside of plywood & elevated dampness readings around posts.

8. Condition: • [Rot](#)

6x6 posts supporting upper deck unconventionally installed ovetop vinyl membrane. Visible plywood rot, water stains underside of plywood & elevated dampness readings around posts.

Implication(s): Weakened structure | Chance of movement

Task: Repair

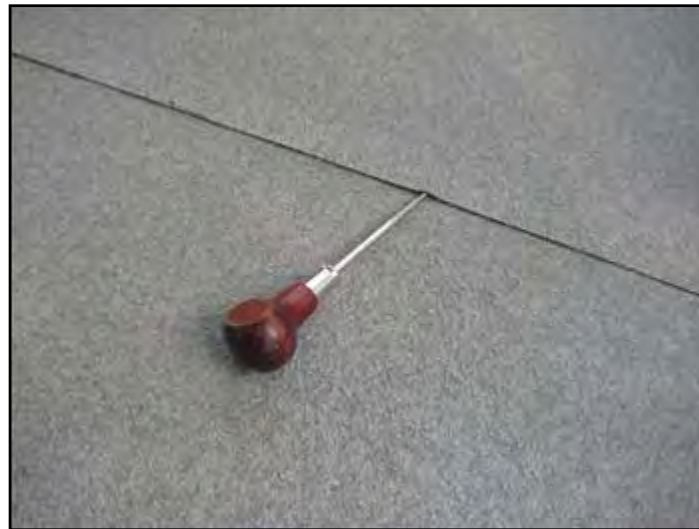
18.

Condition: • Vinyl membrane seams starting to contract & open up.

9. Condition: • Vinyl membrane seams starting to contract & open up.

Task: Replace

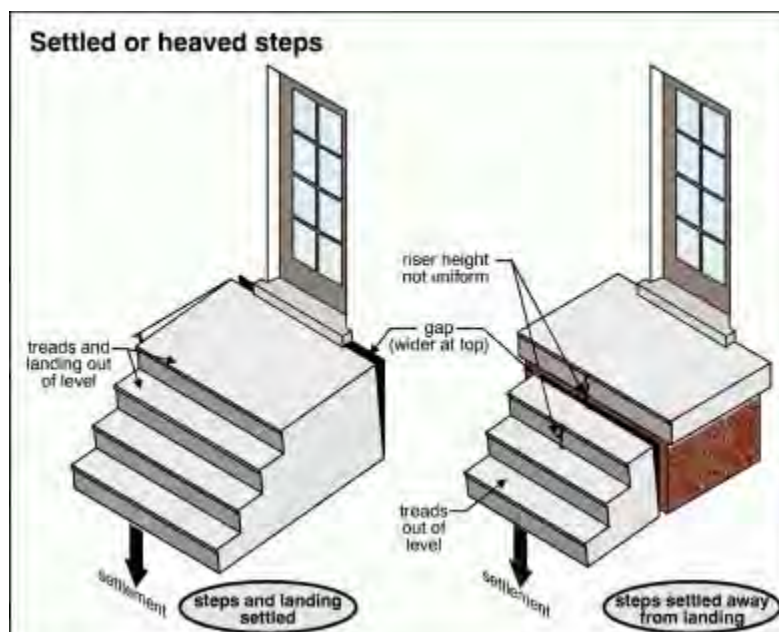
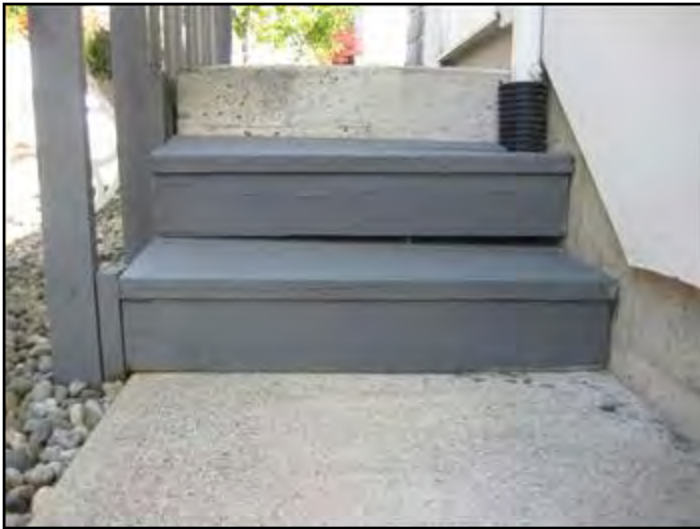
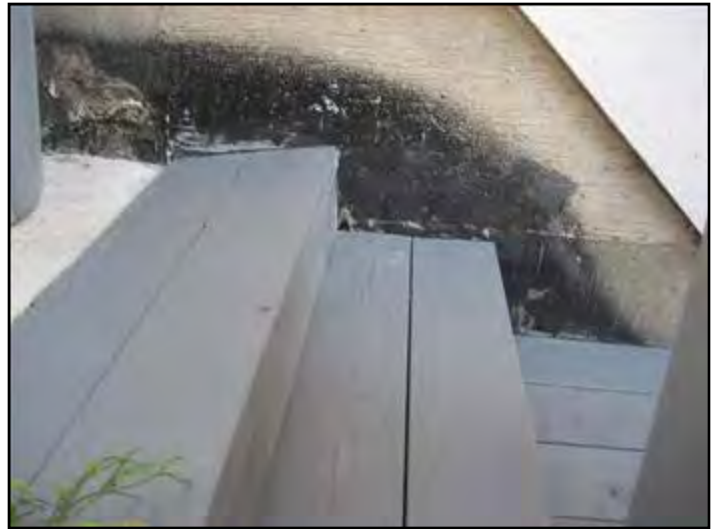
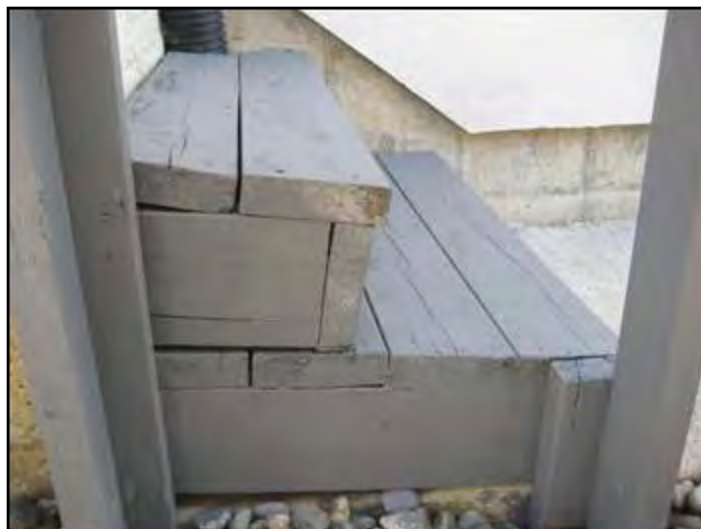
10. Condition: • [Steps or landings settling or heaving](#)

Implication(s): Weakened structure | Trip or fall hazard

Task: Repair

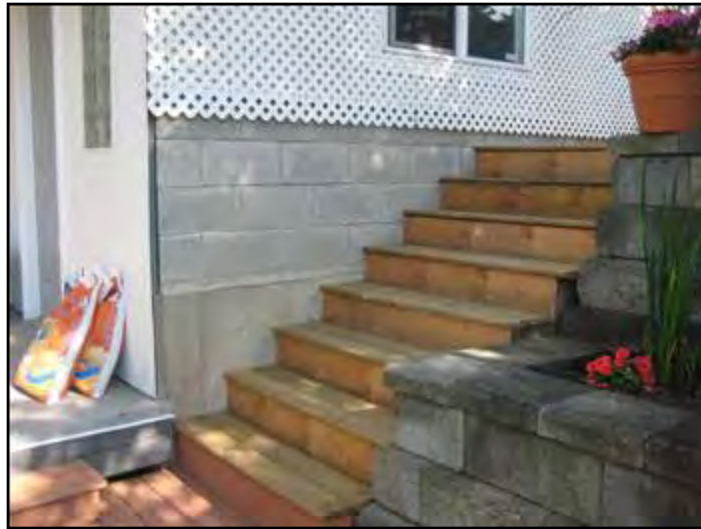
22.

Condition: • [Missing](#)

Two sets of stairs

11. Condition: • [Missing](#)

Implication(s): Fall hazard

Task: Provide

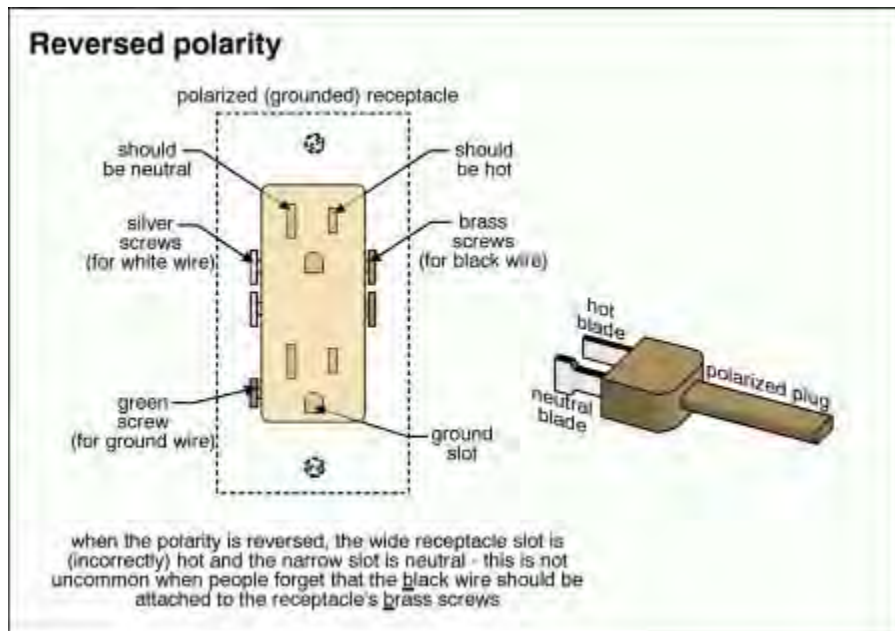
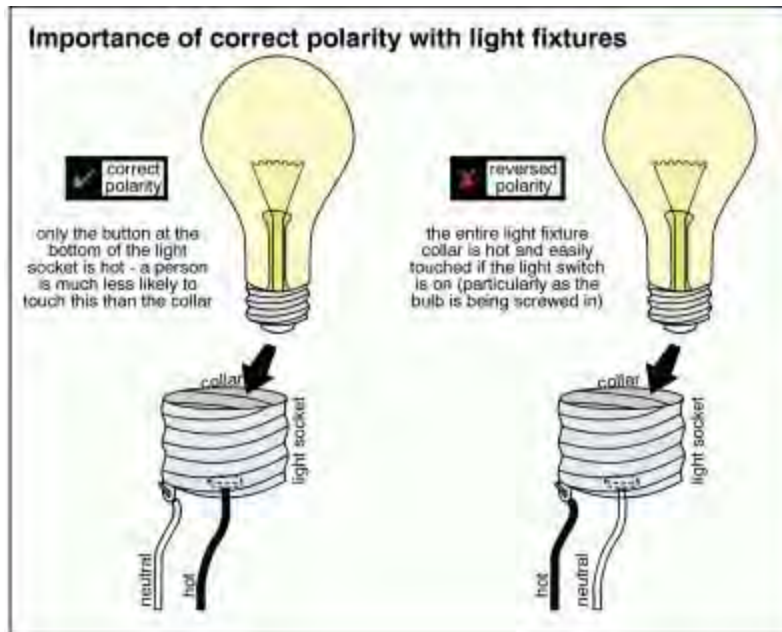
Condition: • [Reversed polarity](#)

16. **Condition:** • [Reversed polarity](#)

Implication(s): Electric shock

Task: Repair

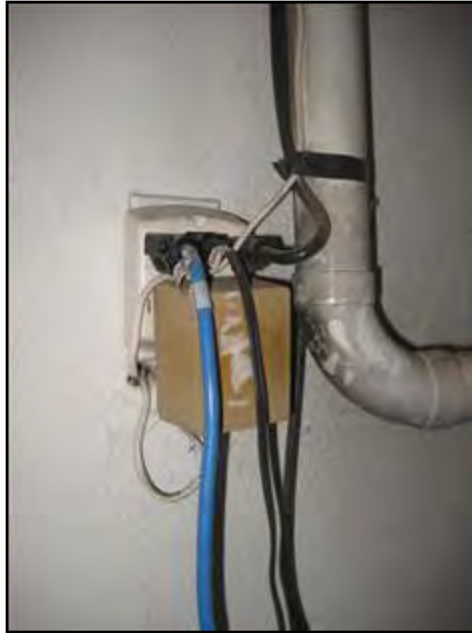
27.

18. Condition: • [Too few outlets](#)

Implication(s): Nuisance

Task: Improve

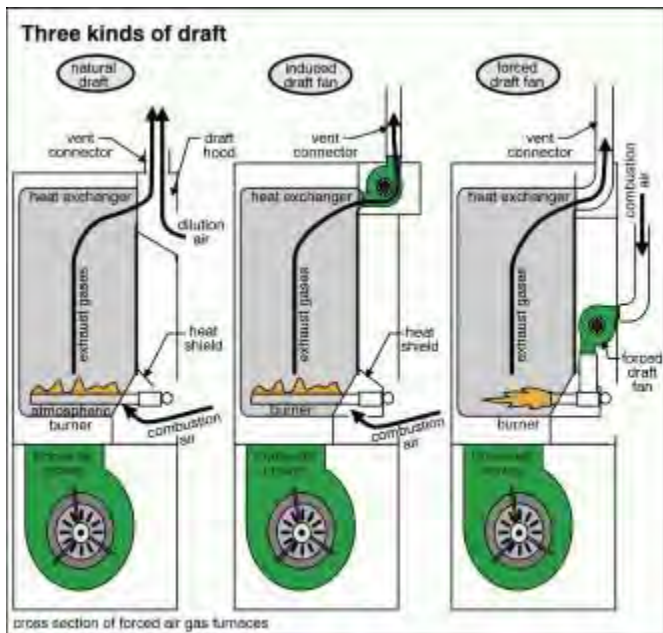
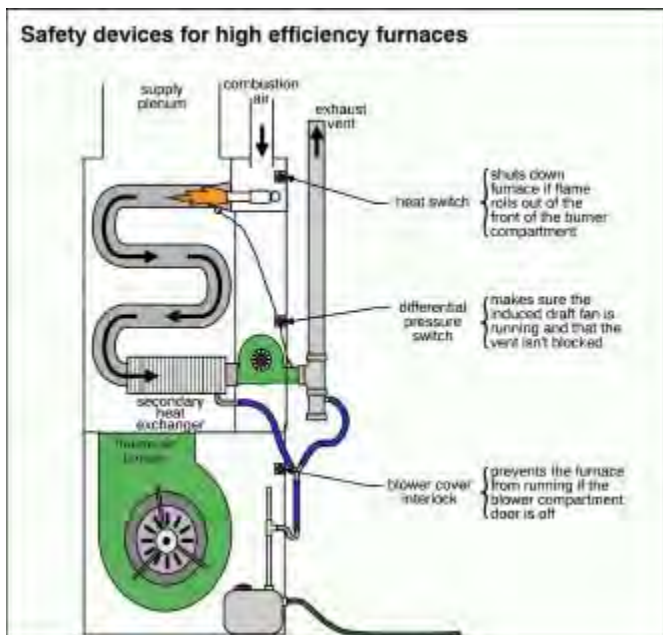
21. Condition: • [Induced draft fan problems](#)

Noisy & some vibration. Service by a licensed gas fitter

Implication(s): Equipment not operating properly | Equipment inoperative | Hazardous combustion products entering home

Task: Further evaluation

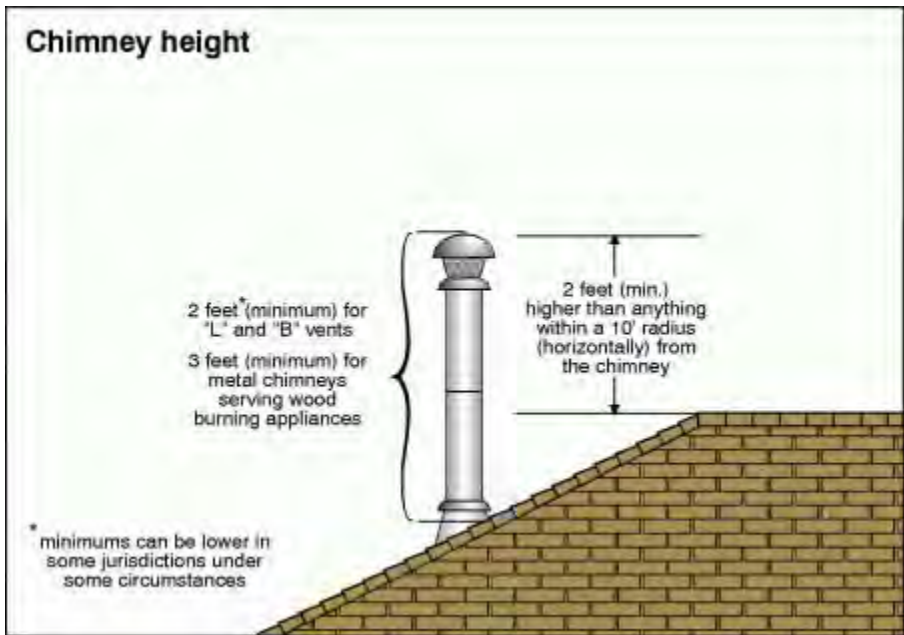
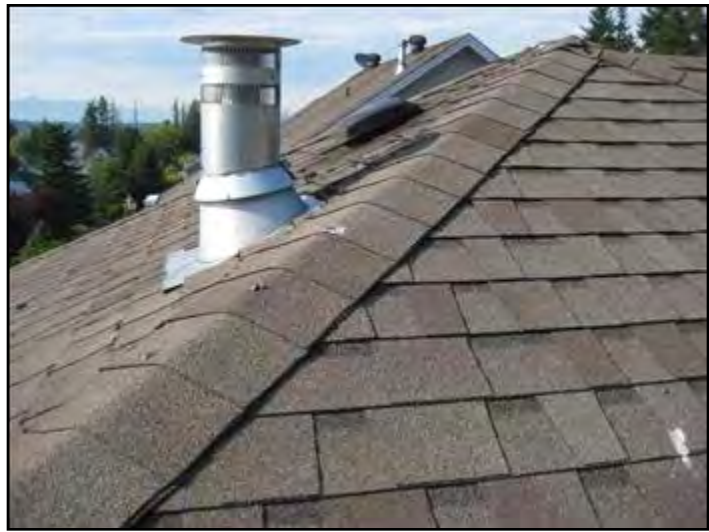
22. Condition: • [Inadequate chimney height above roof](#)

By a licensed gas fitter.

Implication(s): Equipment not operating properly | Hazardous combustion products entering home

Task: Further evaluation

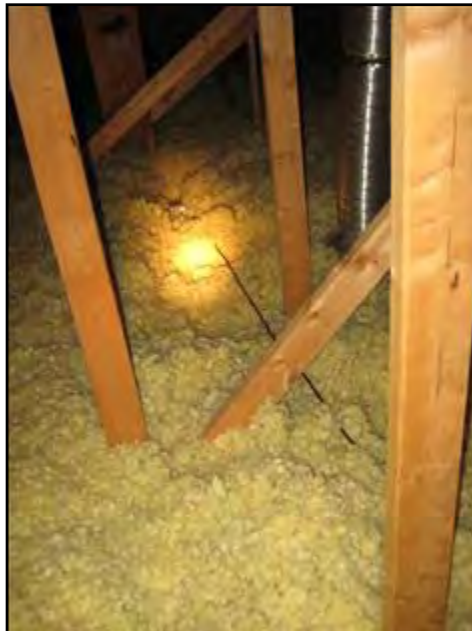
29.

- 23. Condition:** • [Gaps or voids](#)
- Implication(s):** Increased heating and cooling costs | Reduced comfort
- Location:** Various Attic
- Task:** Improve
- Time:** Less than 1 year

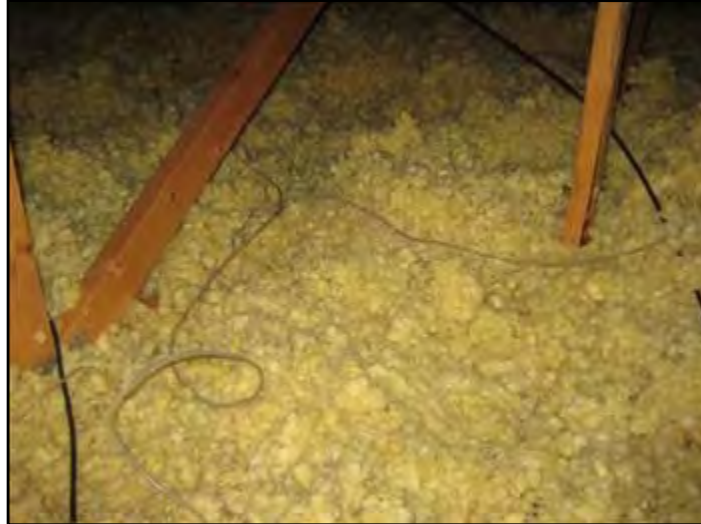
30.

24. Condition: • [Compressed](#)

Implication(s): Increased heating and cooling costs | Reduced comfort

Task: Improve

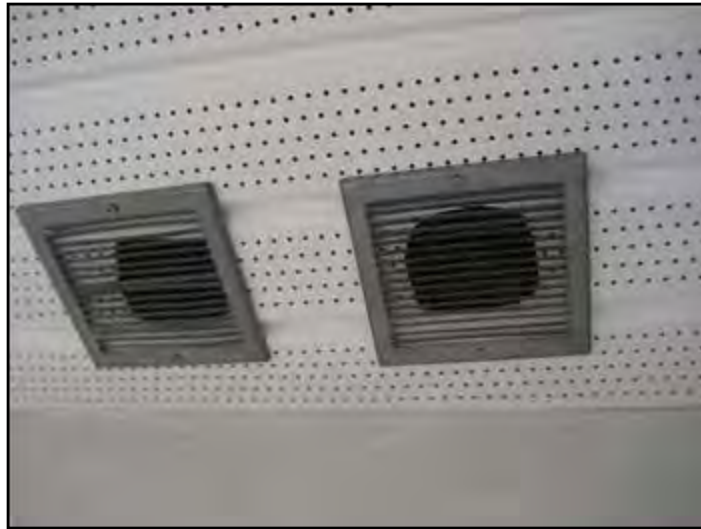
34.

31. Condition: • [Not vented to exterior](#)

Implication(s): Chance of condensation damage to finishes and/or structure

Recommend duct elbow down to existing soffit grill.
